EVALUATION OF
CRACKED BRIDGE DECKS TREATED
WITH VARIOUS
HIGH MOLECULAR WEIGHT
METHACRYLATE RESINS
FOR THE
MONTANA DEPARTMENT OF TRANSPORTATION
WJE NO. 981825

July 27, 2000

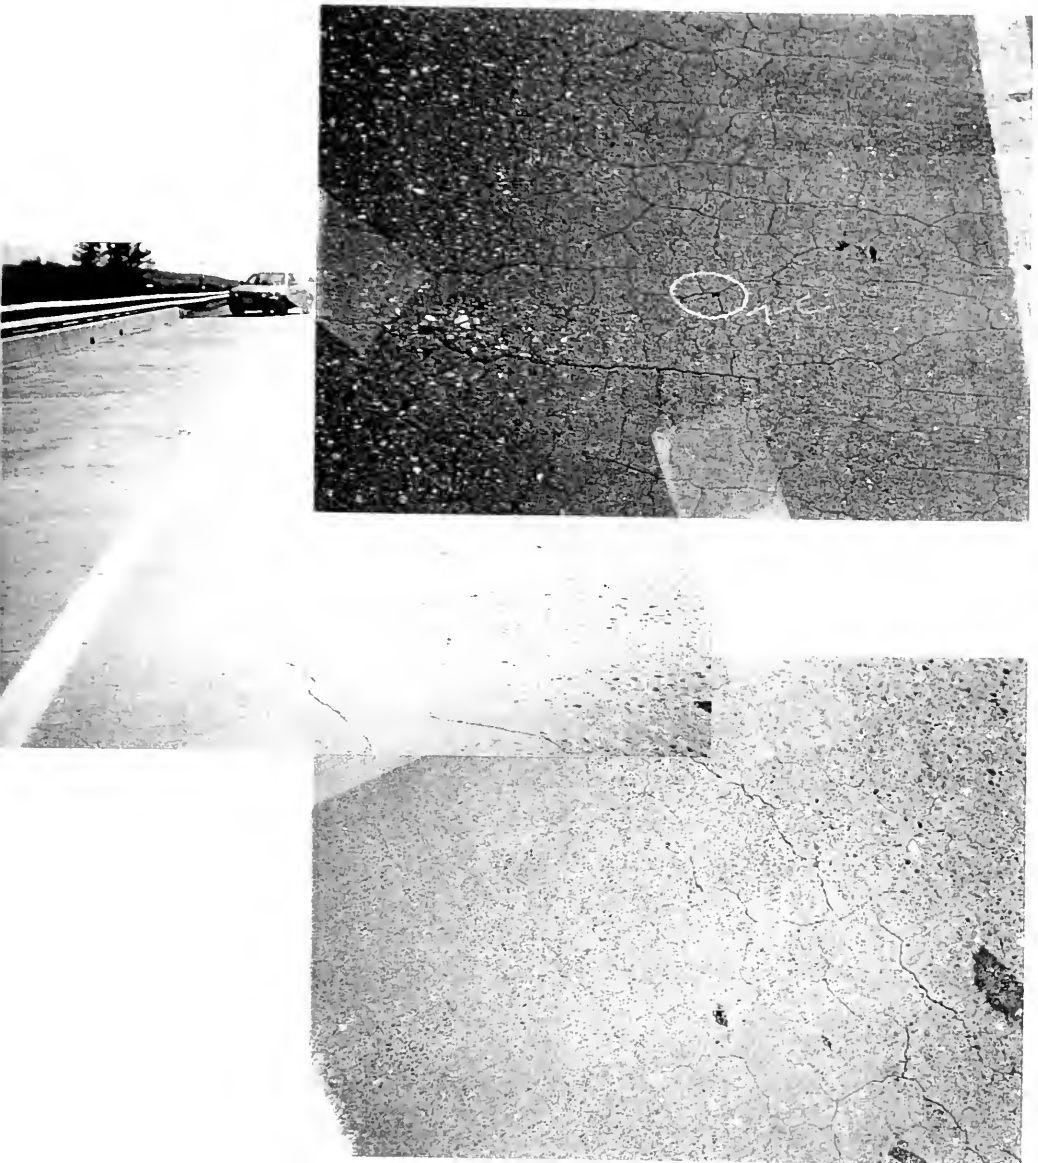
Figure 2 – Longitudinal and map cracking on Bridge Nos. 7 (top), 10 (middle), and 11 (bottom), Three Forks I-90 WB

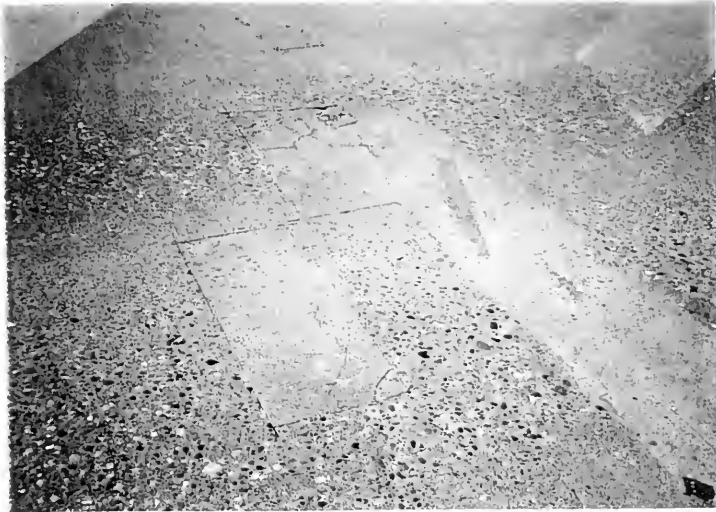
Figure 3 – Deteriorated pcc patches on Bridge 9, Three Forks I-90 WB,
Core location 9-A shown

Bridge 9	I-90-WB	County Rd. Sep.	MP 280.361	Applied 1993	Sika Pronto 19
Precast pcc girders – single span					
Underside	No leaking cracks or efflorescence.				
Top deck	Core 9A in patch showed patches only to top of top mat steel. Patch delaminated at bond line.

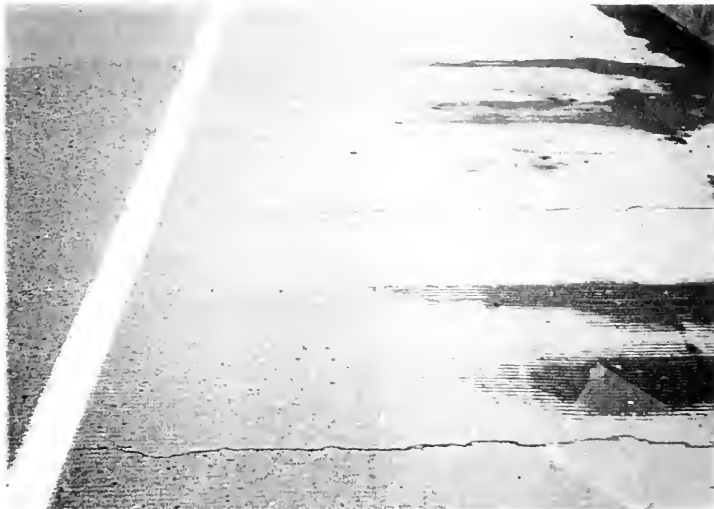
Figure 4 – Transverse deck cracks highlighted after rain on
Bridge No. 18, St. Regis I-90 WB, Core Location 18A

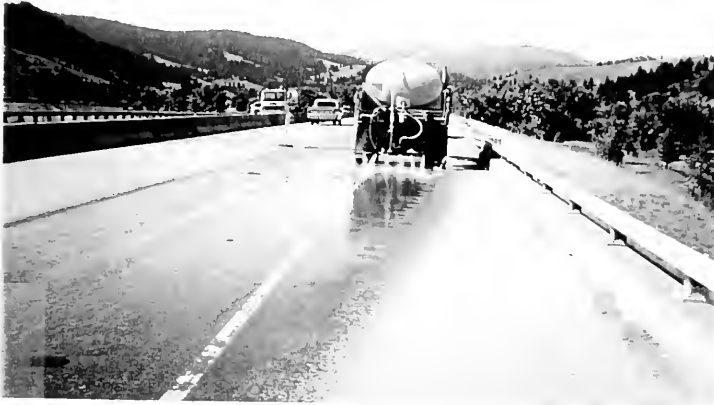
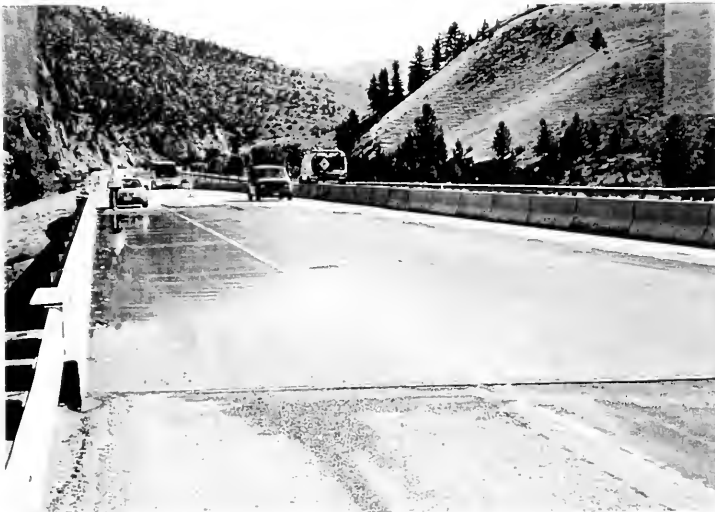
Bridge 13 (I-90 WB, MilePost 143.651) was flooded with water as shown in Figure 5. The through-deck cracks were monitored and no active leakage was noted. Also, new deck cracks in the top surface were not identified as the deck surface dried.

Figure 5 – Wetting surface of Bridge 13 (I-90 WB, Mile Post 143.651)
